Safety Inspection Report

Annual Inspection

Recreation Ground

West Harptree Parish Council

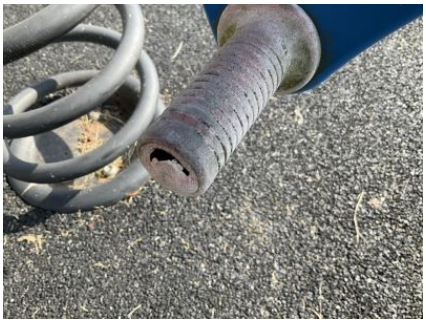
Bolt cap damaged.

Replace.
